## **R.C. Icabone Swimming Pool**

### **Aquatic Facility Assessment**

**Report By:** Connor Riley, P.E. – Counsilman-Hunsaker

**Report Sent:** June 13, 2023

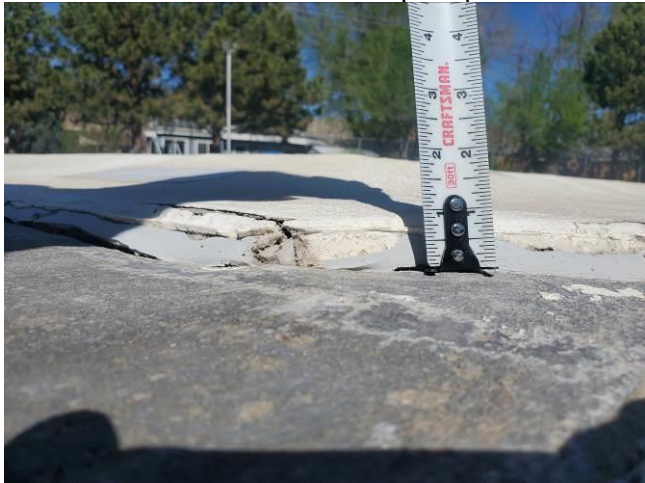
- Surface skimming is only provided at certain locations causing the gutter to flood in areas and dry-out in other areas
  - o Fiberglass liner apron has created uneven conditions (toe-stubbers) around the pool perimeter (Photo 1)

Photo 1: Toe stubbers around pool perimeter

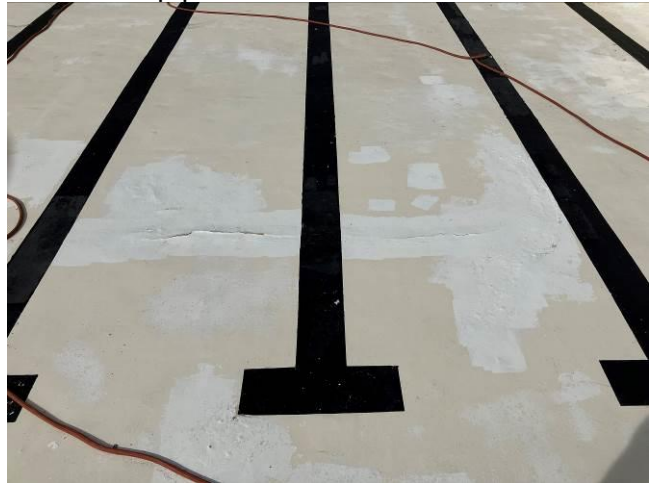
- Lap Pool
  - o Fiberglass liner has failed as evidenced by multiple large cracks (Photo 2)
  - o Pool shell movement is apparent as evidenced by non-consistent rim flow around the gutter (Photo 6)

Photo 2: Lap pool liner failure

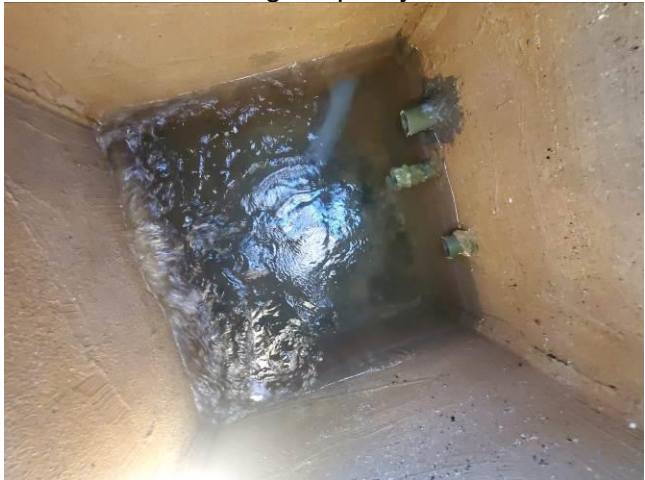
- o Fiberglass liner patch repairs on the apron are not slip resistant
  - o Pool does not have the required amount of surge capacity (Photo 3)
  - o Diving stands are corroded beyond repair (Photo 5)

Photo 3: Limited surge capacity

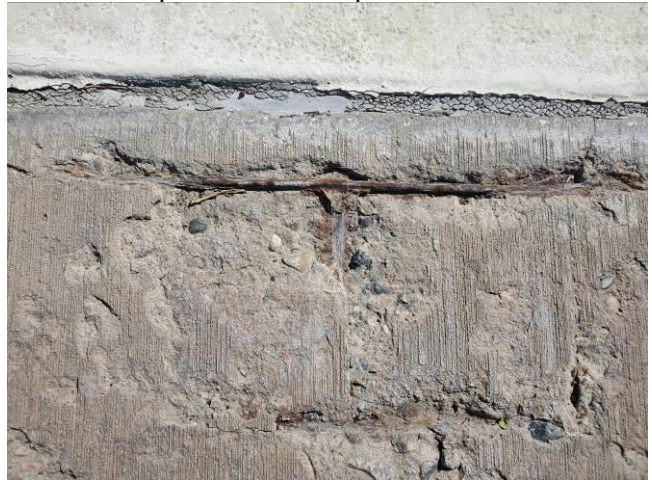
- o Pool deck is crumbling/eroding away in various locations
  - o Rebar staining and exposed rebar was observed in the pool deck at various locations (Photo 4)

Photo 4: Exposed rebar in pool deck

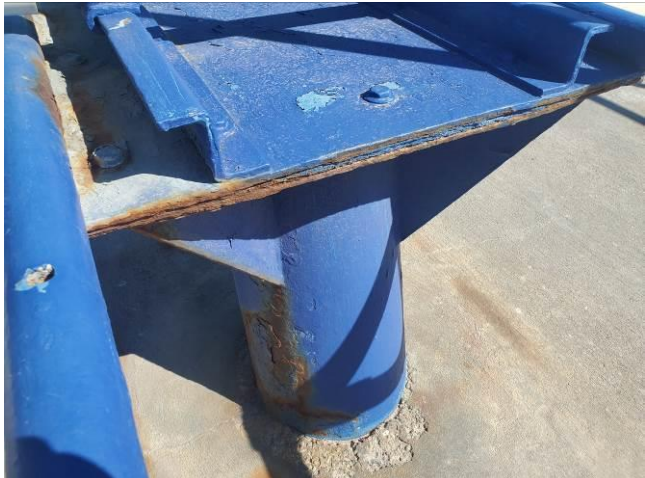
Photo 5: Corroded dive stands

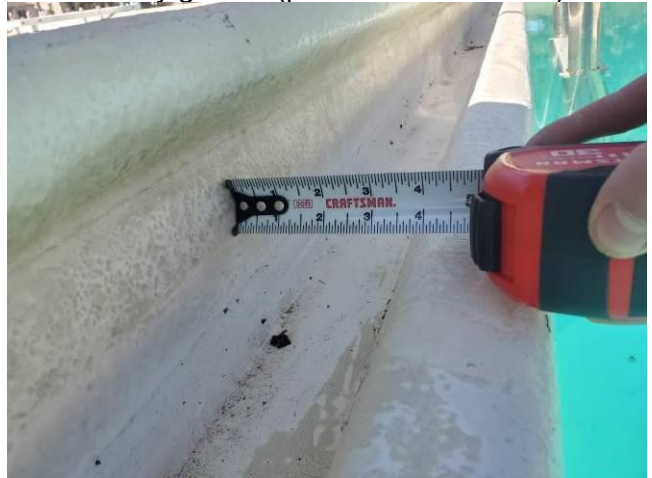
Photo 6: Dry gutters (pool shell movement)

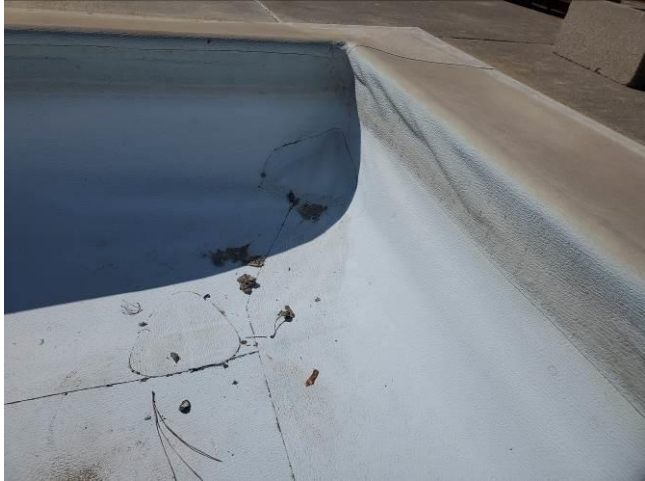
- Wading Pool
  - o Vinyl liner has failed as evidenced by bubbling caused by water between the liner and the concrete (Photo 7)
  - o Pool does not have required number of skimmers

Photo 7: Wading pool liner failure

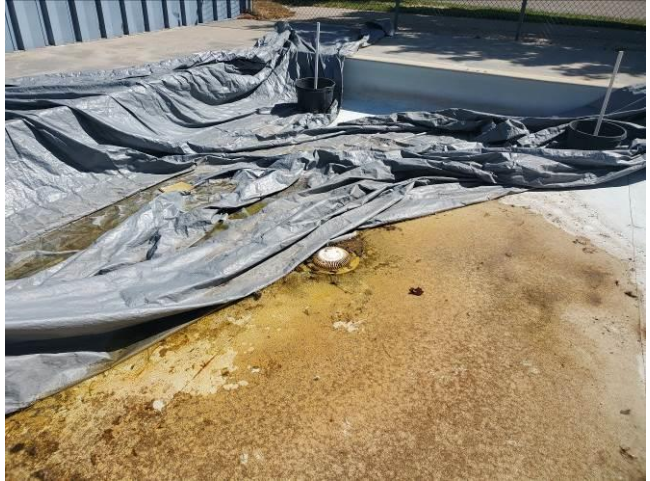
- o Pool does not have required number of main drains and is therefore not VGB compliant (Photo 8)
  - o Vertical depth markers and no-diving symbols/markers are not provided

Photo 8: Single wading pool main drain

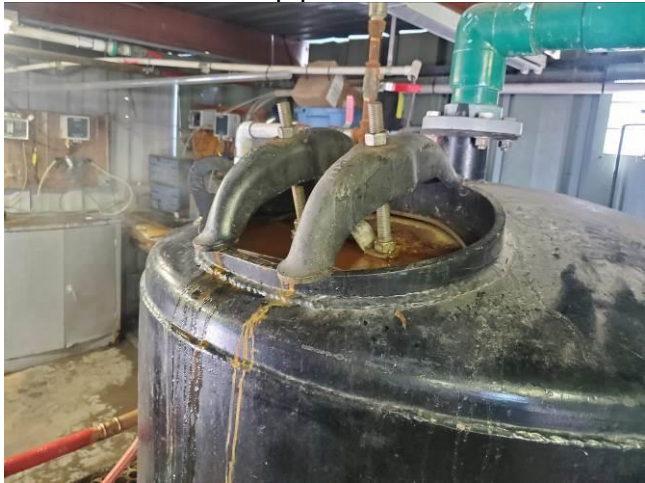
- A flow meter is not provided on the wading pool piping (water velocity/turnover is unknown)
- The lap pool filters are corroded both internally and externally (Photo 9)

- Pinhole leaks have developed in the lap pool filters
- Filter media should be replaced every 3-5 years, C-H is unaware if the media has ever been replaced

Photo 9: Corroded lap pool filters

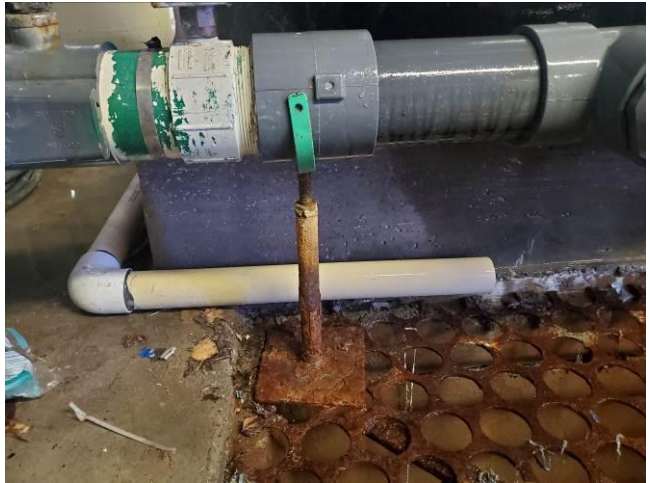
- Exposed metallic valves, flanges, pipe supports, and associated hardware are corroded beyond repair (Photo 10)
- A pump pit is not provided causing regular motor failure/replacement (Photo 11)

Photo 10: Corroded metallic items

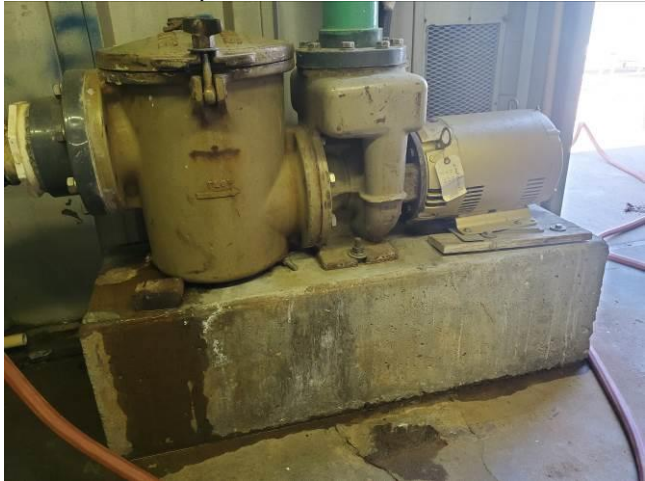
- The lap pool recirculation pump has far outlived its expected life (Photo 11)
- Soft starts or VFDs are not provided for the pool recirculation pumps/motors causing premature failure

- No pressure gauges are provided on the influent and effluent sides of the pumps as required by code (Photo 11)
- Piping and valves are not identified and labeled as required by code

Photo 11: Pump above water level

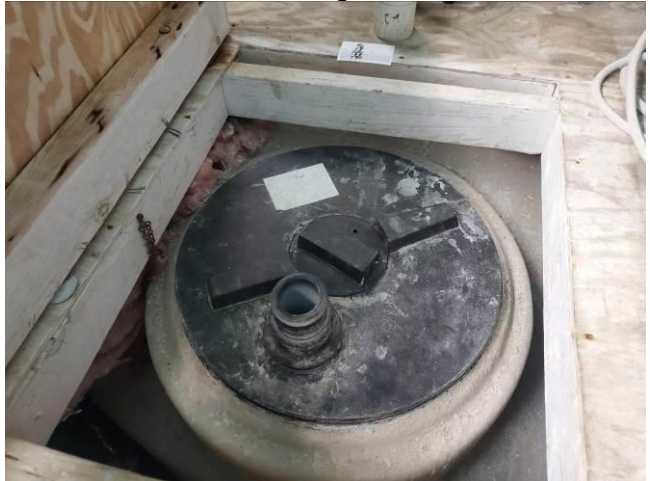
- The sanitizer (liquid chlorine) is stored in the lifeguard breakroom with no cap on the bulk storage tank creating an unsafe environment for the lifeguards (Photo 12)

Photo 12: Chemical storage
